SPECIAL AIRWORTHINESS INFORMATION BULLETIN

SW-04-38
December 24, 2003

This Special Airworthiness Information Bulletin alerts owners and operators of **Eurocopter France EC120B model helicopters** that there could be incorrect positioning of the tail rotor drive shaft damper clamps. This incorrect positioning could lead to interference of the two damper half-clamps with the drive shaft tube and cause scoring on the shaft. In time, the interference could result in tail rotor drive shaft failure.

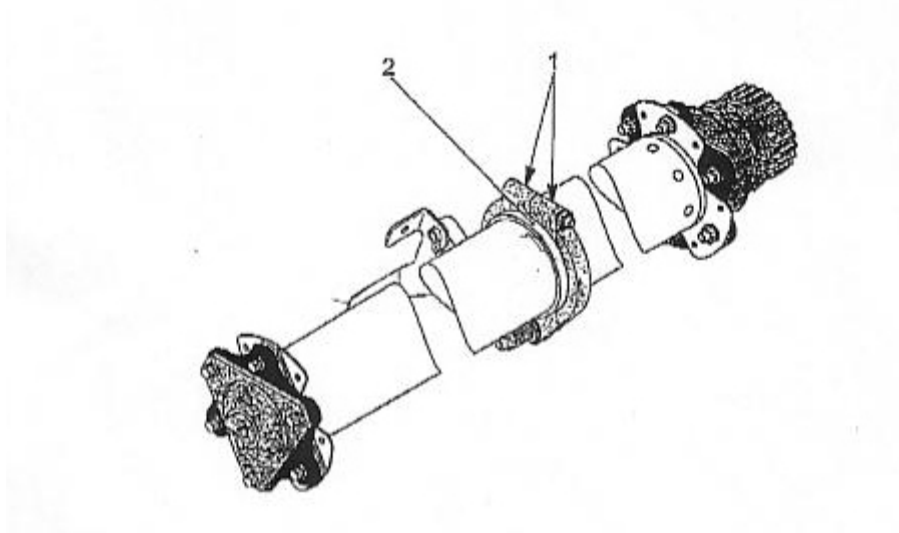
FIGURE 1

Eurocopter advised that a case of incorrect tail rotor drive shaft damper positioning was discovered during a maintenance operation. This incorrect positioning led to interference of the two damper half-clamps with the drive shaft tube and caused a score on the shaft. In time, this interference could result in tail rotor drive shaft failure.

- For aircraft serial numbers 1362 and lower, follow the recommendations contained in Eurocopter Alert Telex #65A004.
- If the two half-clamps (1) are not fully positioned on the friction ring (2) remove, check for scoring of the shaft and if required replace any unairworthy parts.
